THIS PAST YEAR I HAVE BEEN RESTORING SOLEX 40-PI CARBS FOR PIM VAN DE RIET (35G CLASSICS B.V.). OUR GOAL WAS TO RESTORE THESE CARBS TO MAKE THEM LOOK JUST AS THEY WOULD HAVE LEFT THE FACTORY OF THE DEUTSCHE VERGASER GESELLSCHAFT.

THIS RESTO STRIP IS THE FIRST OF THREE PARTS. THIS FIRST RELEASE WILL FOCUS ON THE RESTORATION OF THE CARBS THEMSELVES. IN THE NEXT PARTS THE REBUILDING AND ADJUSTMENT WILL BE DISCUSSED.

## 911 Resto Strip...

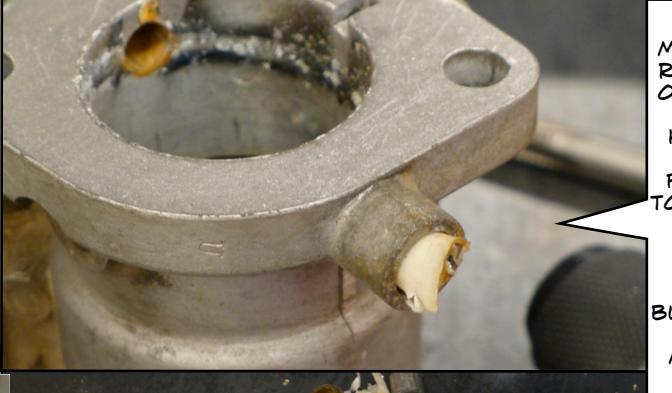
WHILE STRIPPING THESE CARBS MOST OF THEM HAD ALREADY BEEN REPAIRED WITH TEFLON BUSHINGS. ORIGINALLY THE THROTTLE SHAFTS USED THE ALUMINUM OF THE HOUSING ITSELF AS THE BEARING SURFACE. THIS WOULD WEAR SO FAST THAT A LOT OF REPAIRS HAD TO HAPPEN AFTER ONLY 10.000KM. THE THROTTLE SHAFT IS A WEAK POINT OF THESE CARBS. THE HOUSINGS WILL ALL RECEIVE BRONZE BUSHINGS AND THE BUTTERFLY BORES WILL BE MILLED TO A SLIGHT OVERSIZE. LASTLY MATCHING BUTTERFLIES WILL BE TURNED ON THE LATHE.

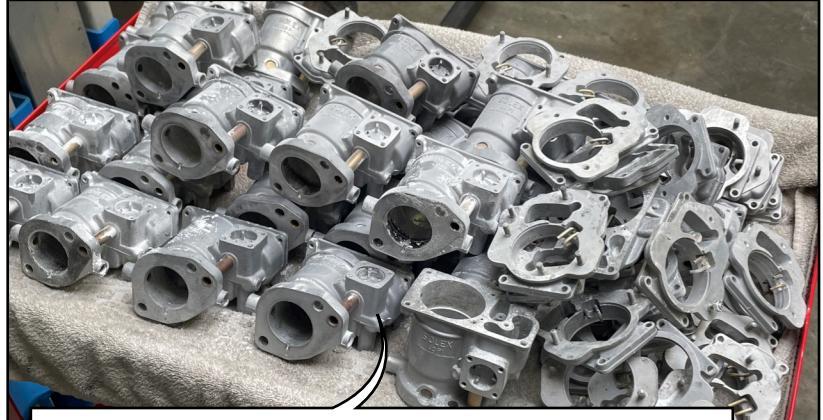
AFTER A COUPLE OF CLEANING EXPERIMENTS FOR THE VARIOUS CARB PARTS WE HAVE CHOSEN TO CLEAN THE ALUMINUM CARB BODIES AND TOPS BY SODA BLASTING THEM. OTHER CARB PARTS THAT ARE MADE OF ZAMAK ARE TUMBLED IN CERAMIC MEDIA AND ARE ULTRASONICALLY CLEANED.

SODA BLASTING CLEANS THE ALUMINUM WHILE KEEPING ITS MATT APPEARANCE. IT CLEANS THE MATERIAL WITHOUT DAMAGING THE SURFACE. SODA IS ALSO SOLUBLE IN WATER WHICH MEANS THAT AFTER CLEANING YOU WON'T BE LEFT WITH BLASTING MEDIA IN YOUR CARBS.

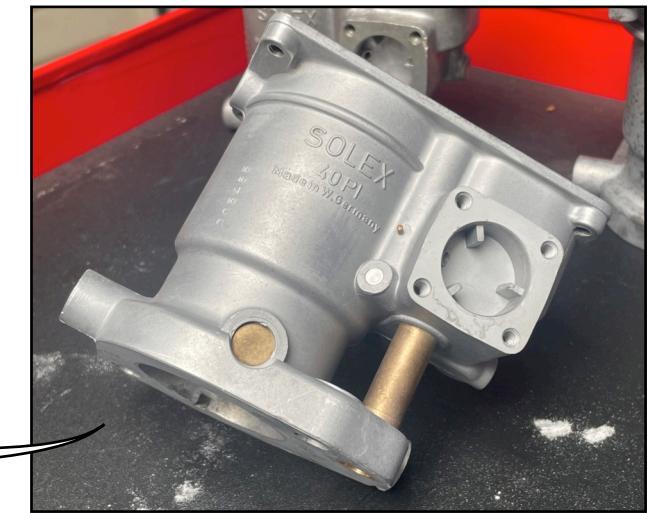
THE VERY FIRST SOLEX CARBS DID

NOT HAVE A PRODUCTION NUMBER STAMPED ON THE SIDE OF THE HOUSING. AS THE PRODUCTION WENT ON 4,5 AND EVENTUALLY G

DIGIT NUMBERS WERE STAMPED.

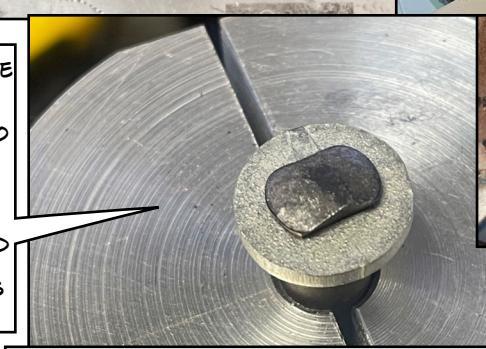
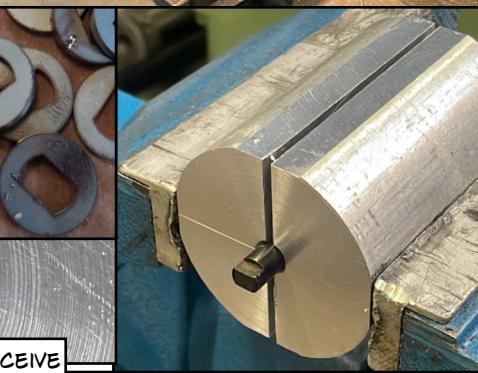
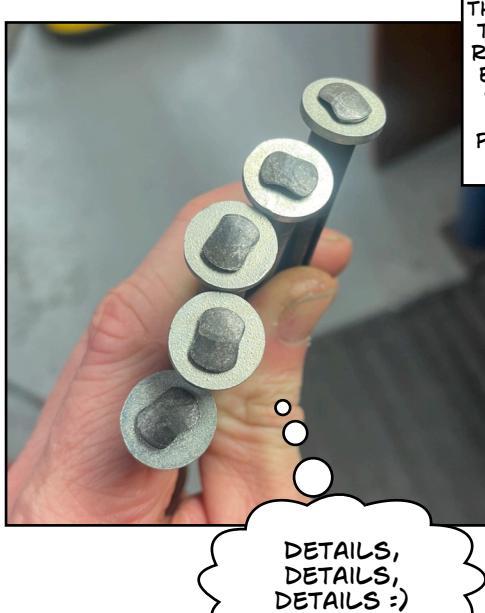
THE THROTTLE SHAFTS HAVE A WASHER ON THE END THAT IS PEENED ON THE SHAFT. THE REPRODUCTION SHAFTS ARE PEENED BY WHAT LOOKS LIKE A HAMMER AND CHISEL. THE WASHERS ARE ALSO LARGER THAN THE ORIGINAL ONES. TO GET THE ORIGINAL LOOK SHAFTS WERE SOURCED WHICH HAD NO WASHERS. NEW WASHERS WERE LASERCUT TO THE ORIGINAL DIMENSIONS. IT TOOK A COUPLE OF TRIES TO GET THE PEENING TO LOOK RIGHT.

FIRST TEST: LEFT IS A REPRO SHAFT, THE MIDDLE IS A SHAFT WITH A LASERCUT WASHER AND TO THE RIGHT IS AN ORIGINAL SHAFT. I THINK WE ARE ON TO SOMETHING.

TO KEEP THE SHAFT FROM DEFORMING WHILE PEENING I MADE AN ALUMINUM TOOL. WITH A COUPLE OF WELL PLACED HITS OF A BALL-PEEN HAMMER THE PRESSING OF THE ORIGINAL SHAFT WAS REPLICATED.

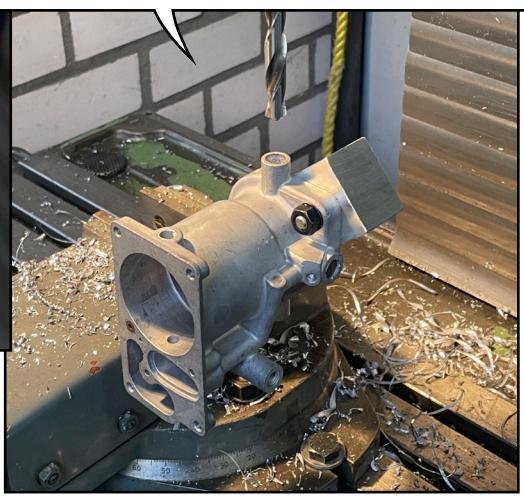
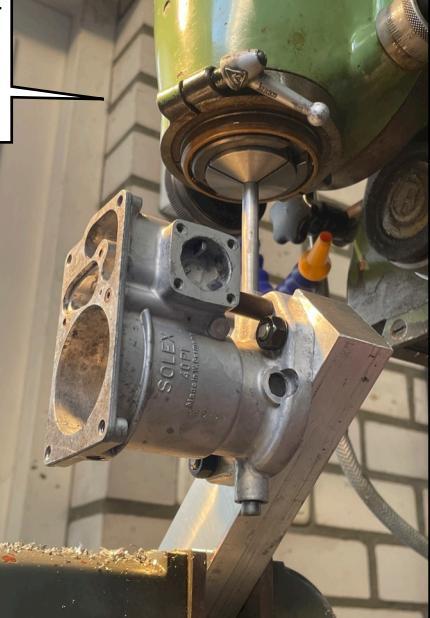
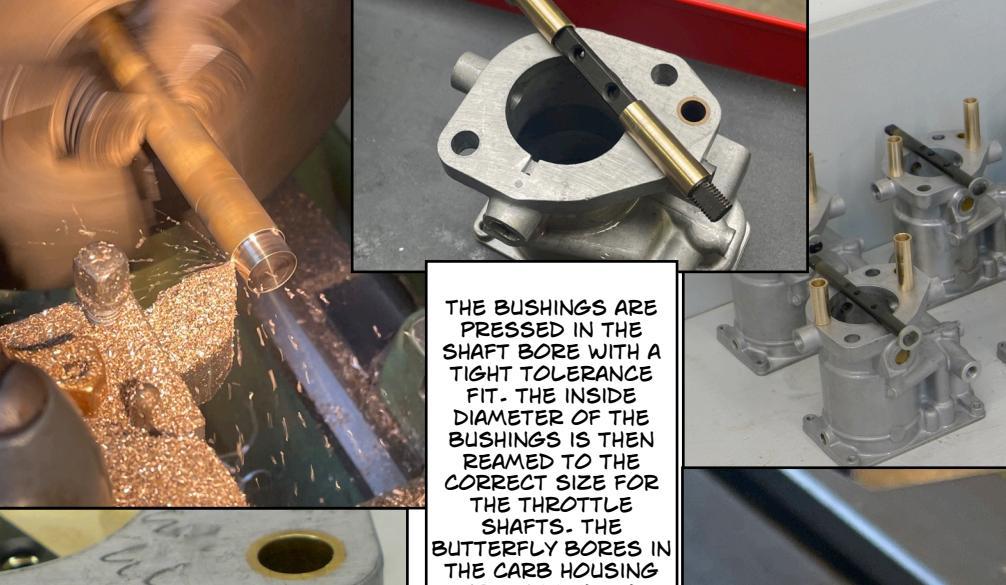
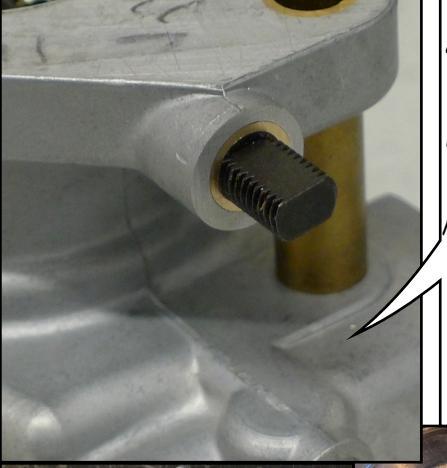
THE THROTTLE SHAFT BORE IS PREPARED TO RECEIVE THE BRONZE BUSHINGS. THE CARBS THAT HAVE NOT RECEIVED THIS TREATMENT BEFORE WILL BE ALIGN-BORED TO AN OVERSIZE FROM 8MM TO 10MM. THE SHAFT IS 8MM IN DIAMETER THEREFORE BUSHINGS WITH A DIAMETER OF 2MM CAN BE TURNED. A PRECISION SHAFT OF 8MM IS USED TO CHECK IF THE BORE IS PERFECTLY ALIGNED BEFORE DRILLING.

SHAFT BORE WITH A TIGHT TOLERANCE FIT. THE INSIDE DIAMETER OF THE BUSHINGS IS THEN REAMED TO THE CORRECT SIZE FOR THE THROTTLE SHAFTS. THE BUTTERFLY BORES IN THE CARB HOUSING ARE MILLED TO 40,4MM IN ORDER TO REMOVE WEAR THAT HAPPENS WHEN THE BUTTERFLY RIDES AGAINST THE SIDE OF THE BORE. MILLING IS ALSO DONE SO THAT THE BUSHINGS MATCH THE RADIUS OF THE BORE. JUST A MOMENT I WILL BE RIGHT BACK....JUST HAVE TO DO THIS 30 TIMES... OKAY I'M DONE LET'S MOVE ON :).

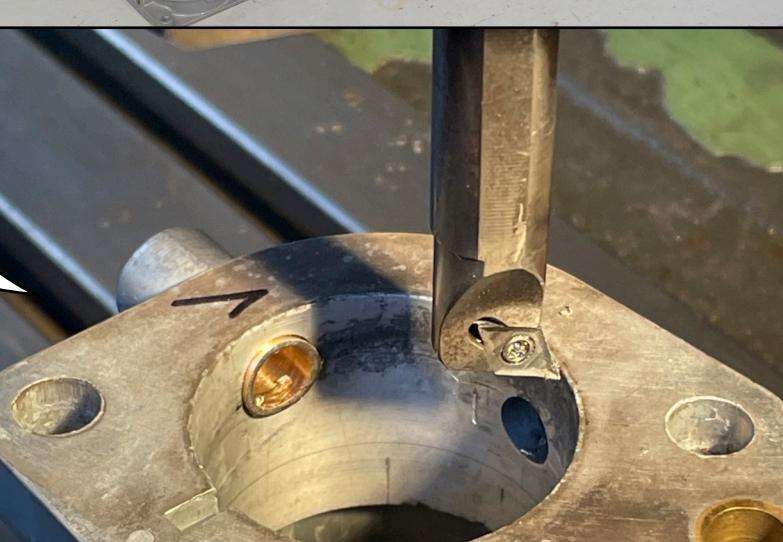
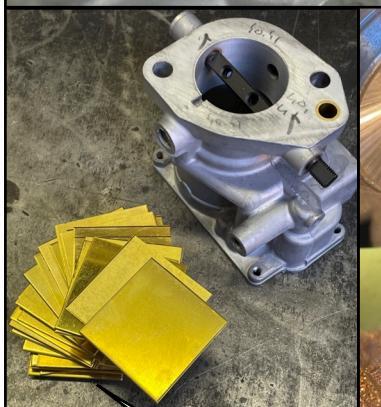
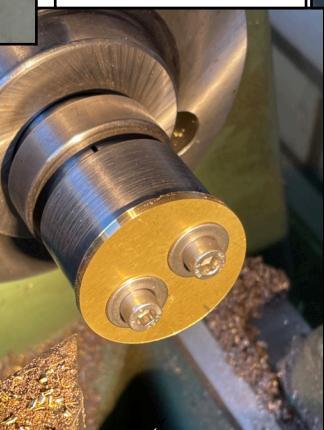
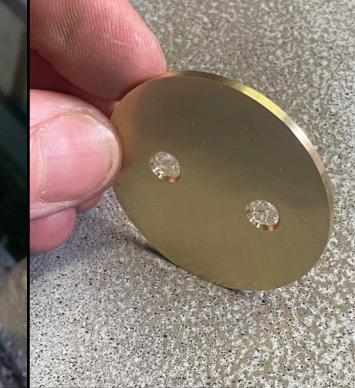
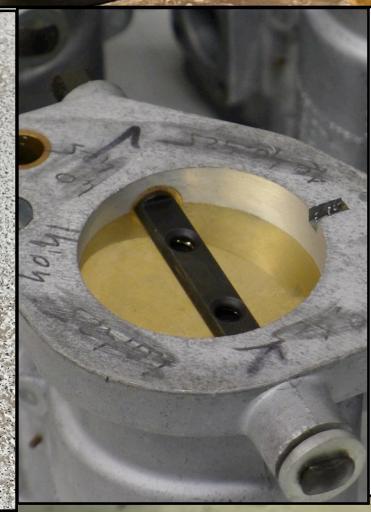
OVERSIZED BUTTERFLIES ARE TURNED OF BRASS THAT IS 1,5MM THICK- AFTER DRILLING THE SCREW HOLES THE BUTTERLY IS TURNED 0,02MM SMALLER THAN THE BORE- BY USING A LAMP YOU CAN SEE IF THERE IS ANY LEAKAGE COMING FROM THE CIRCUMFERENCE WHERE THE BUTTERFLY MEETS THE BORE-

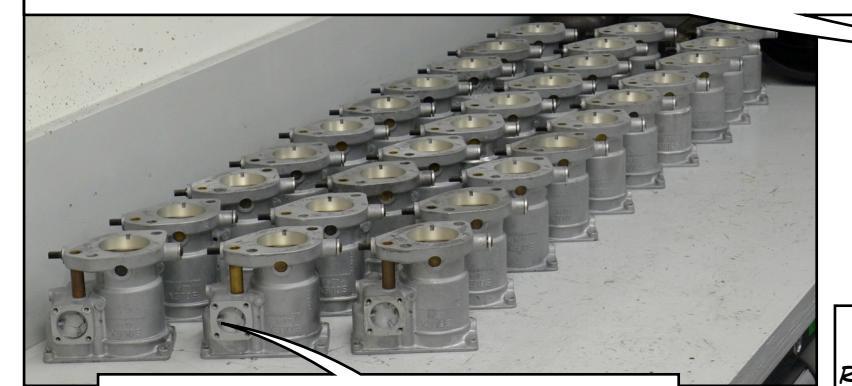
30 PROCESSED CARBS READY TO BE REBUILT!
